Safety Alert Trunnion Repairs

Industry Alert

Risks associated with trunnion pin type suspension systems

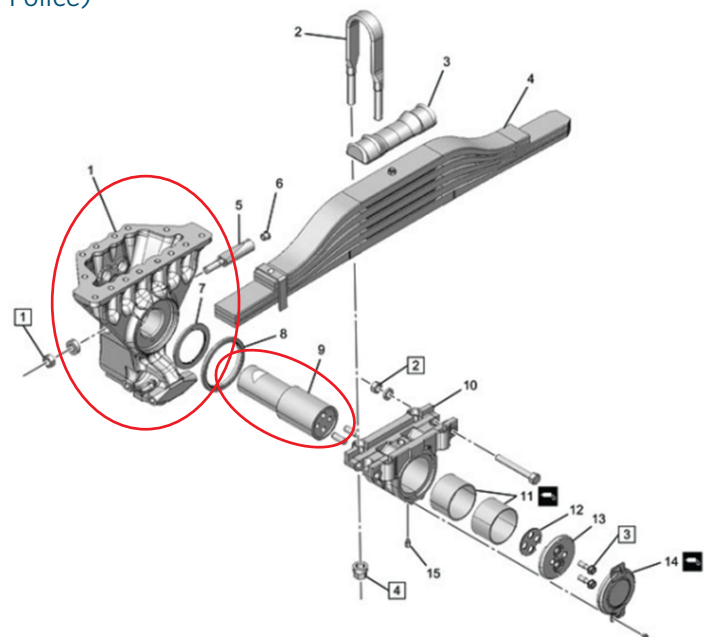
Figure 2: Exploded view of trunnion pin type suspension (source Isuzu NZ)

Vehicle manufacturers using this type of suspension DO NOT support any repair, machining or refurbishment of the trunnion pin or the trunnion housing (indicated in figure 2).

Manufacturers do not support any refurbishment of the unit and specify if wear is measured with either the trunnion pin or the trunnion housing, either or both items must be replaced with OE parts. Manufacturers do not offer aftermarket parts for these suspension systems through their dealer network and service providers are reminded of their obligations under the [Land Transport Rule: Vehicle Repair 1998](#).

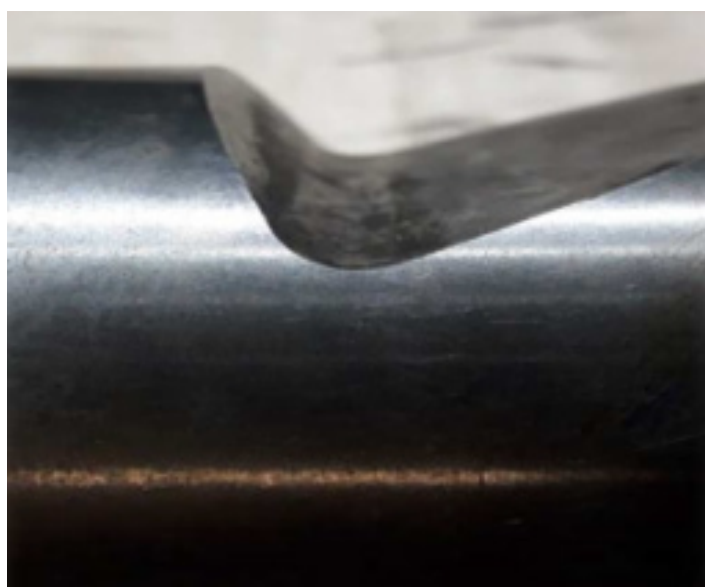
Figure 5: Genuine pin (source NZ Police)

Aftermarket trunnion pins are available but metallurgic analysis of some of them found inherent flaws in both the steel strength and subsequent machining. One difference observed between an OE pin and a sub-standard aftermarket pin can be seen in figure 5. The shape of the notch has a profound effect on the load path transferred through the pin to the trunnion housing.

The OE pin (figure 5) is designed to have a tolerance fit in the housing. The steel grade and notch can sustain large lateral load transfer that would provide a long service life.

OE service parts purchased from a reputable supplier are recommended for both the pin and the housing assembly as these manufacturers don't carry rebuilt or reconditioned items and have no repair method for them.

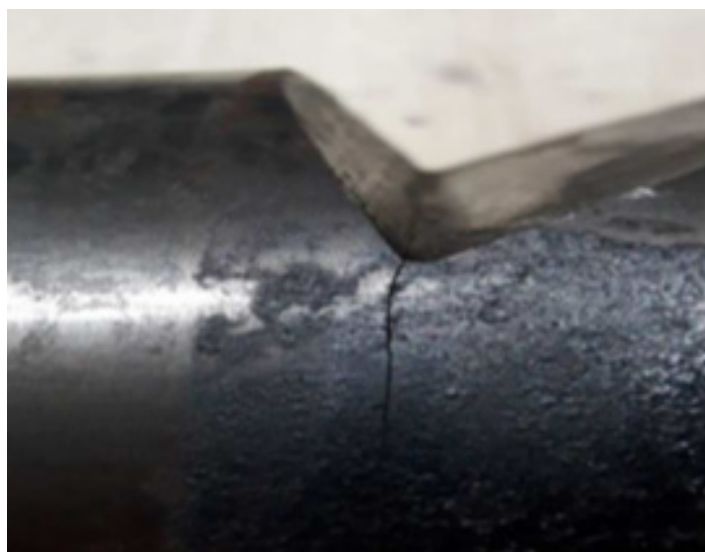
Figure 6: Substandard pin (source NZ Police)

Sub-standard aftermarket pins (figure 6) were found to have a lower steel grade and a notch design that promotes cracking at its base. The resulting fatigue and stress would lessen the expected service life, leading to premature failure. The use of these pins must be avoided.
