CRITICAL RISK SAFETY ALERT: WAKA KOTAHI TAKING ACTION ON SANWA SEIKI BRAKE SYSTEMS ON SOME NISSAN UD TRUCKS - ISSUED 17 MARCH 2021

Waka Kotahi taking action on Sanwa Seiki brake systems on some Nissan UD trucks

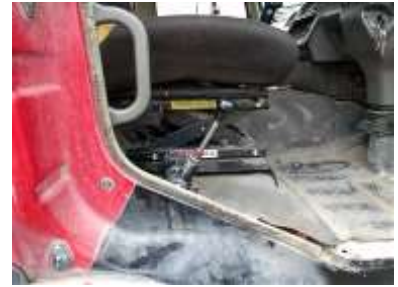
The location of the park brake lever on the driver's right (next to the driver's door) makes it susceptible to being knocked as the driver climbs in and out of the vehicle, unintentionally releasing the park brake. The location of the control valve also makes it more susceptible to contaminants getting into the operating mechanism.

The operating mechanism is prone to wear over time that is not immediately apparent from a visual inspection and this is aggravated by the location of the lever.

When the operating mechanism is worn, operators of the vehicle may believe the park brake has fully engaged when it hasn't.

The factory-supplied Sanwa-Seki Park Brake Control Valve (see above) must be replaced with an alternative park brake control valve, preferably by one that is mounted to the left of the driver's seat and that also has a graduated control action.

Moving the control valve to the left side of the driver's seated position will reduce the risk of the valve failing due to dirt, dust or contamination of the mechanism and/or the park brake unintentionally disengaging.

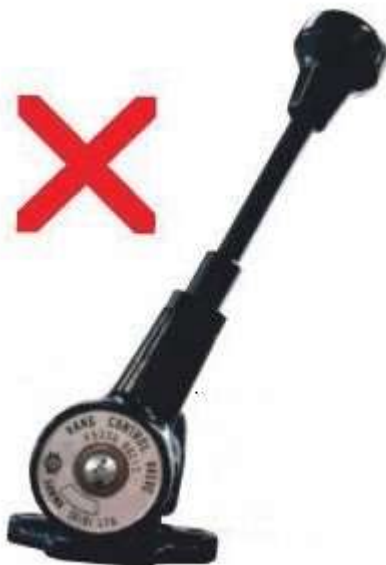
The following models of Nissan trucks originally had Sanwa Seiki brake systems installed and on the driver's right:

- **CW380**
- **CK330**
- **CG400**
- **CM180**
- **CW400**
- **CG380**
- **CW330**
