Safety Alert Trunnion Repairs

Industry Alert

Risks associated with trunnion pin type suspension systems

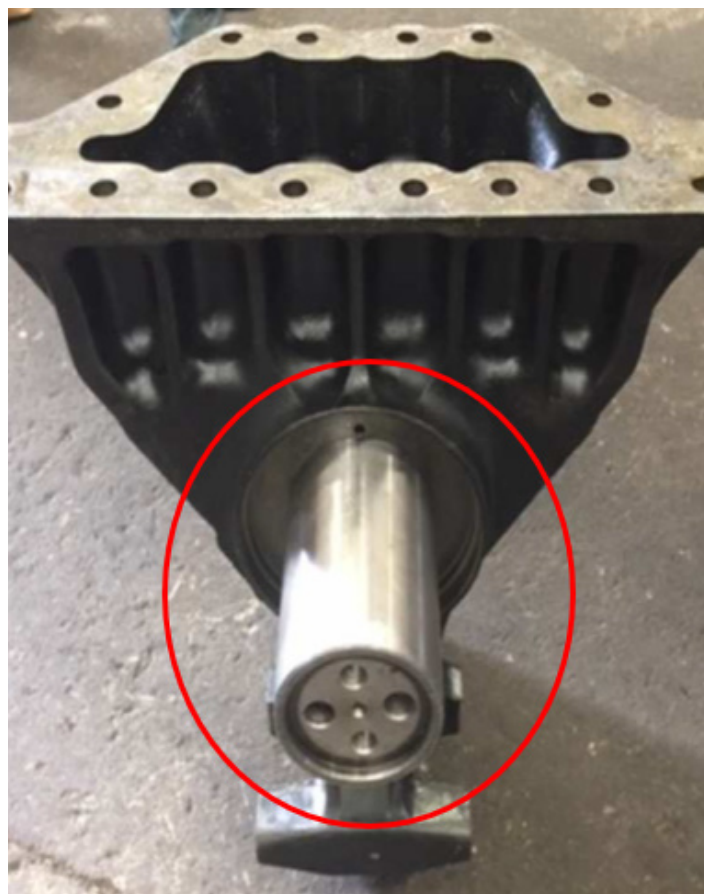
An incident where the trunnion pin was ejected from a heavy vehicle suspension causing fatal injuries was investigated by the Police Commercial Vehicle Safety Team (CVST). The Police investigation and report in 2019 found that the incident was mainly caused by the trunnion pin breaking. In addition, the overhaul techniques and replacement parts used during a recent refurbishment of the truck's rear suspension assembly were of concern.

The Police investigation found that the incident was mainly caused by the trunnion pin breaking. The broken portion of the trunnion pin separated from the suspension assembly and was ejected from the wheels into the path of another vehicle. The investigation also found that the overhaul techniques and replacement parts used during a recent refurbishment of the truck's rear suspension assembly were cause for concern and should be investigated further with support from manufacturers and repairers.

Figure 1: Trunnion housing and pin assembly (source NZ Police)

- Understand the risks of reconditioning this type of trunnion pin suspension system
- Only use Original Equipment (OE) trunnion pins and trunnion housings purchased from a reputable supplier for this type of suspension system
- Ensure that these suspension units are repaired according to the manufacturer's instructions by suitably qualified people.

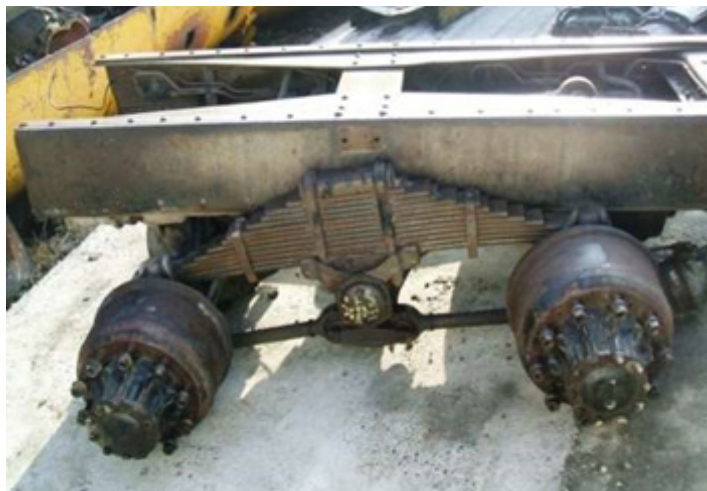
Figure 3: A typical tandem axle trunnion type rear suspension system (source NZ Police)
